Department of Energy  
Office of Legacy Management

Subject: Submittal of the Addendum to Final Wetland Monitoring Report at Monticello, Utah

## **Addendum to Final Results of Wetland Restoration and Monitoring at the Monticello Mill Tailings Site and Monticello Vicinity Properties**

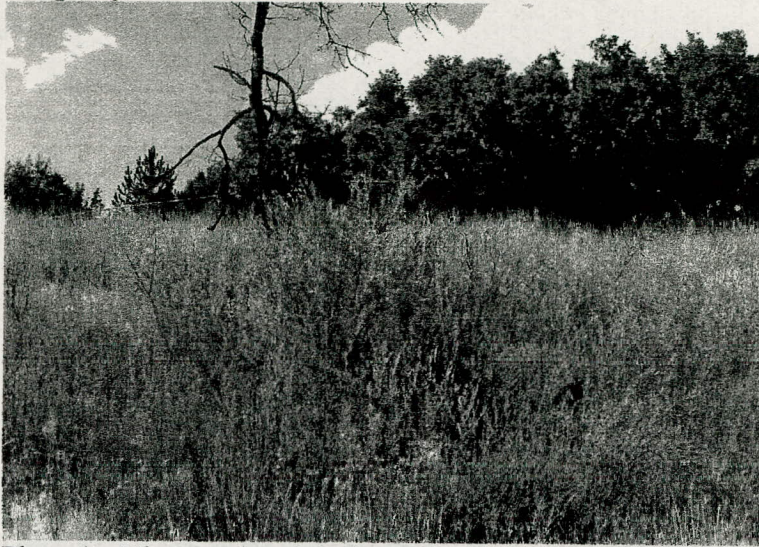
Photo 1 – View north, original portion of Tree Seep 1

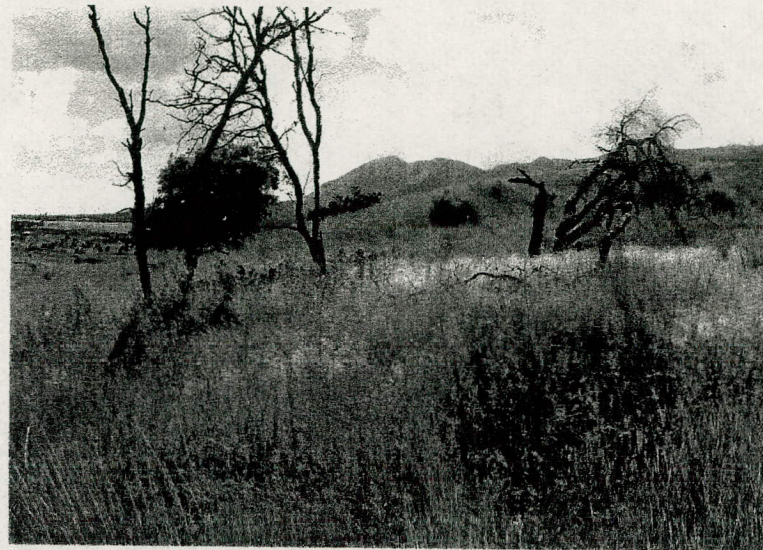
Photo 3 – Tree Seep 3, view west

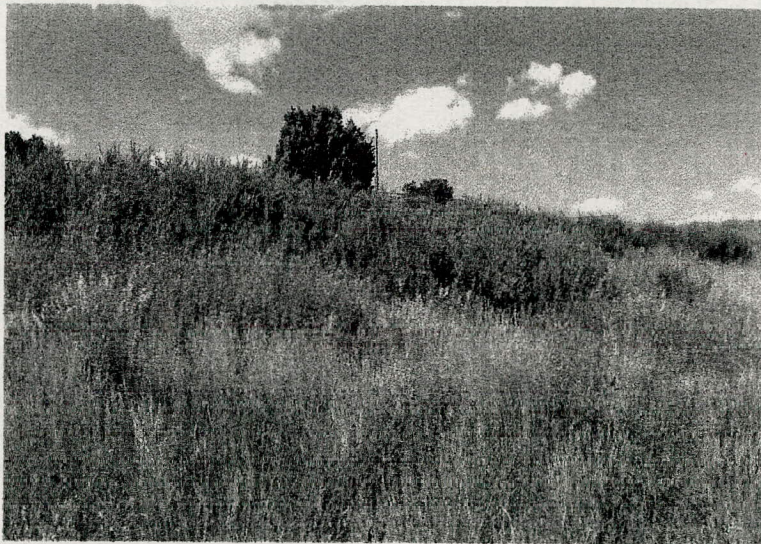
Photo 2 – Tree Seeps 1 & 2, view northeast, including expanded area

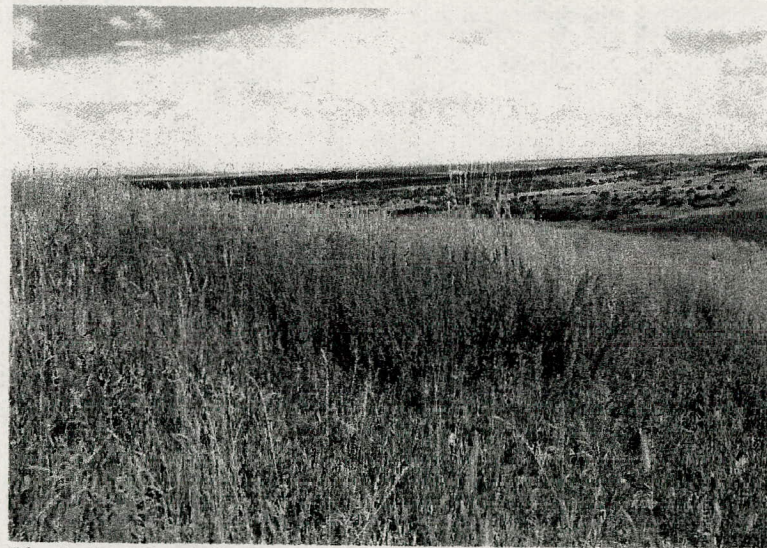
Photo 4 – Woodpile Seep, view east

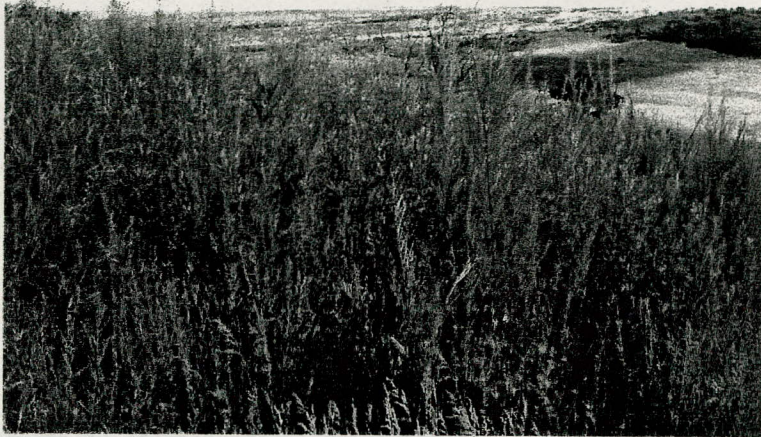
Photo 5 – Cemetery Seep, view southeast

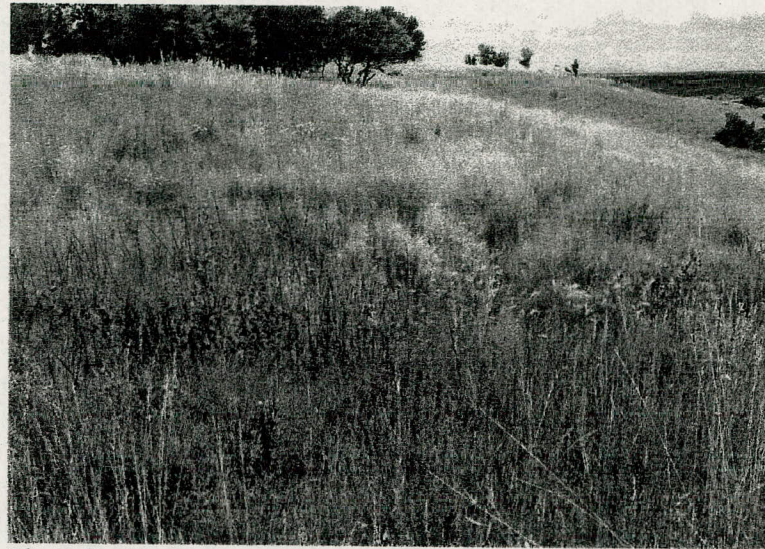
Photo 7 – Upper Seep, main wetland, view east

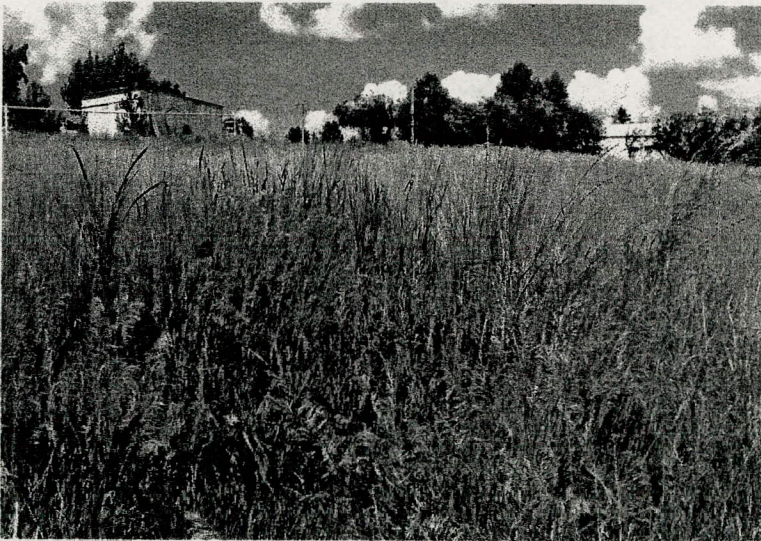
Photo 6 – Upper Seep, northwest corner of wetland, view ENE

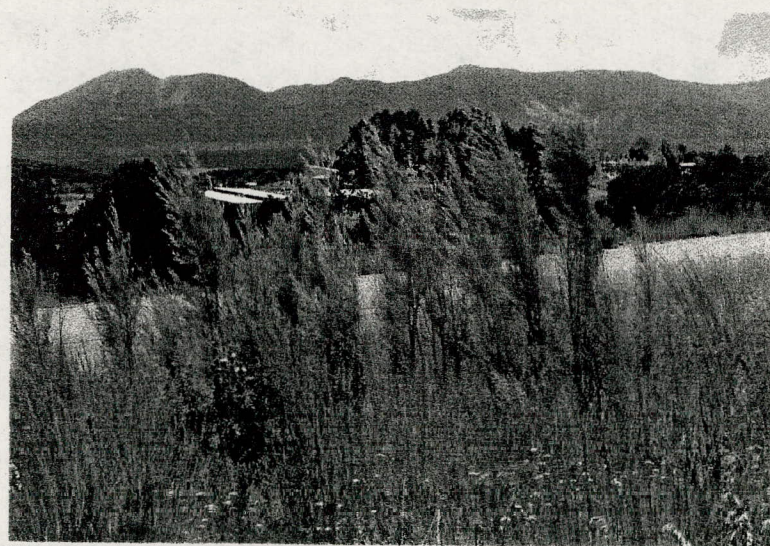
Photo 8 – Lower Southwest Seep, view southwest

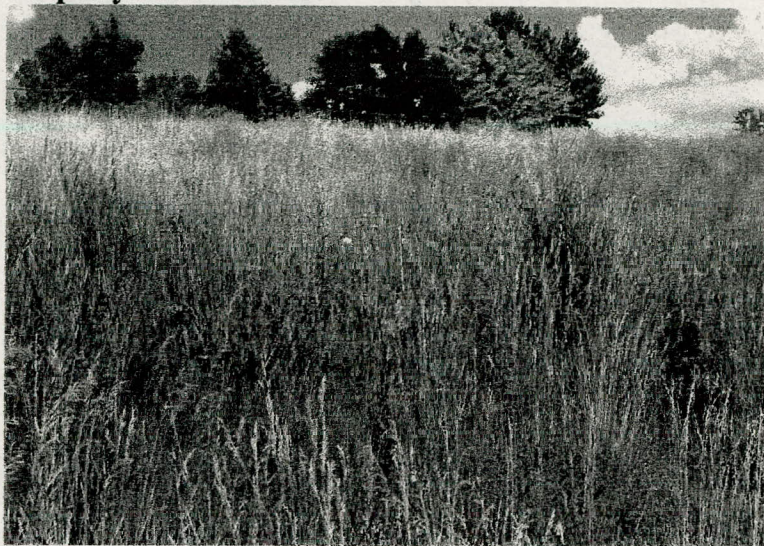
Photo 9 – Tiny Seep, view northeast

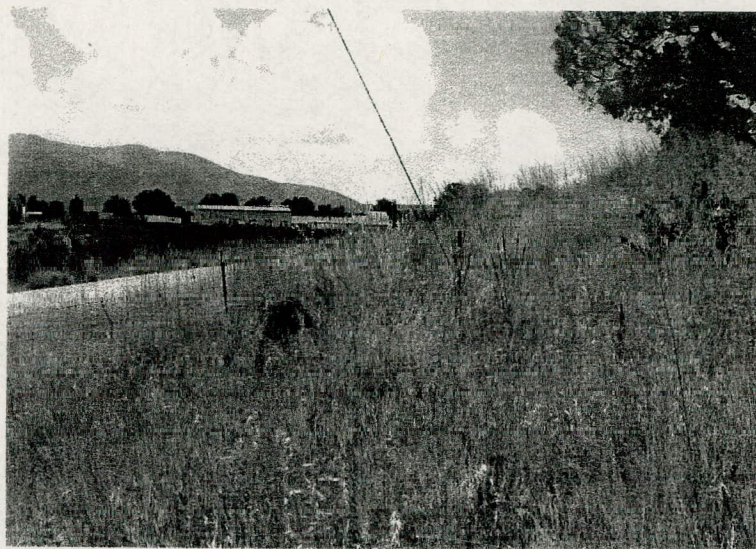
Photo 11 – Surprise #2 Seep, view west

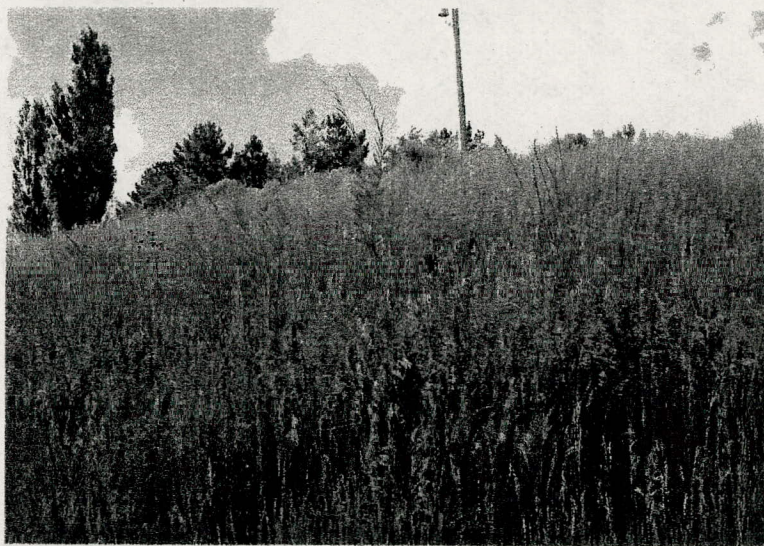
Photo 10 – Surprise #1 Seep, view northwest

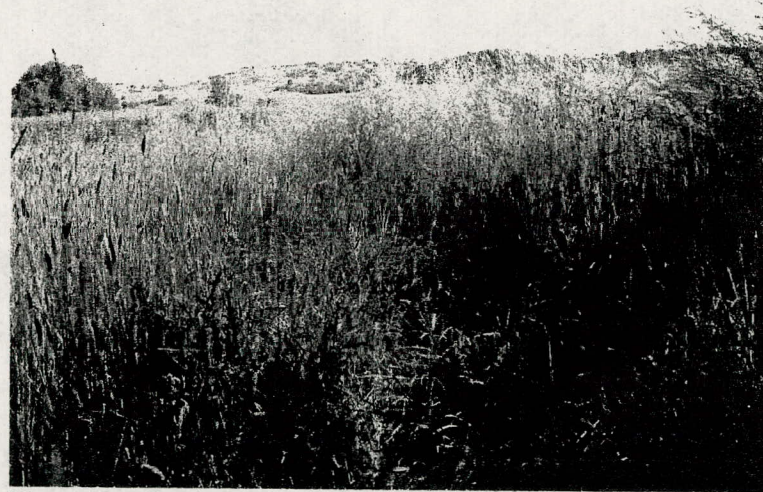
Photo 12 – Stock Pond, northern drainage, view south

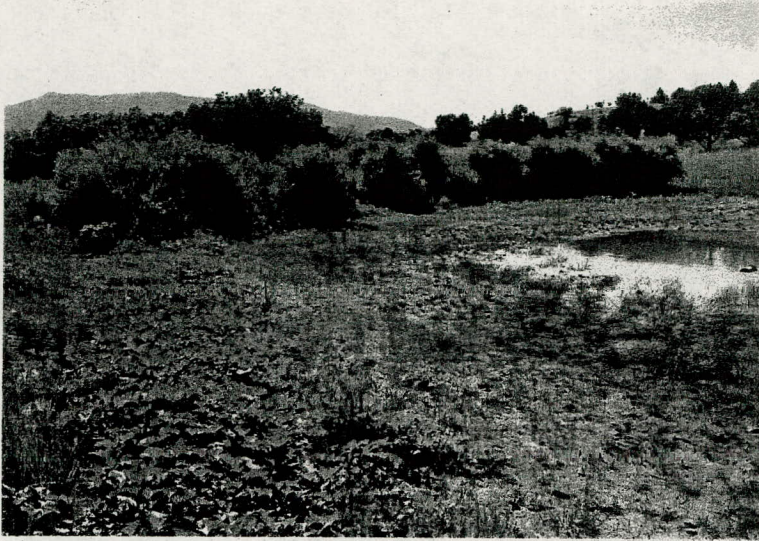
Photo 13 – Stock Pond, southern edge of pond, view west

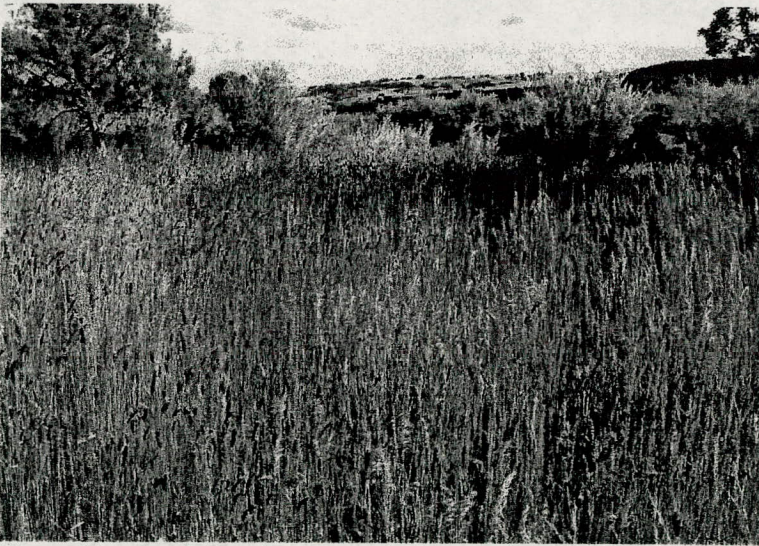
Photo 14 – Stock Pond, western drainage, view southeast

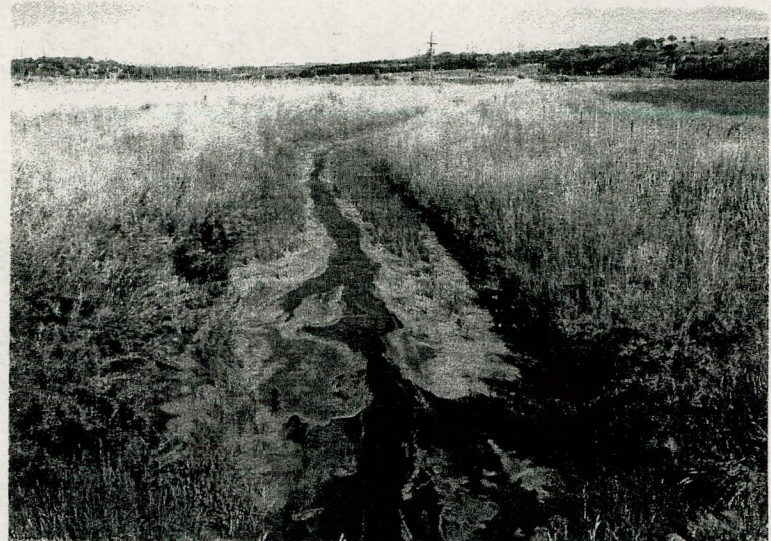
Photo 15 – Phase III Montezuma Creek, view east from culvert crossing

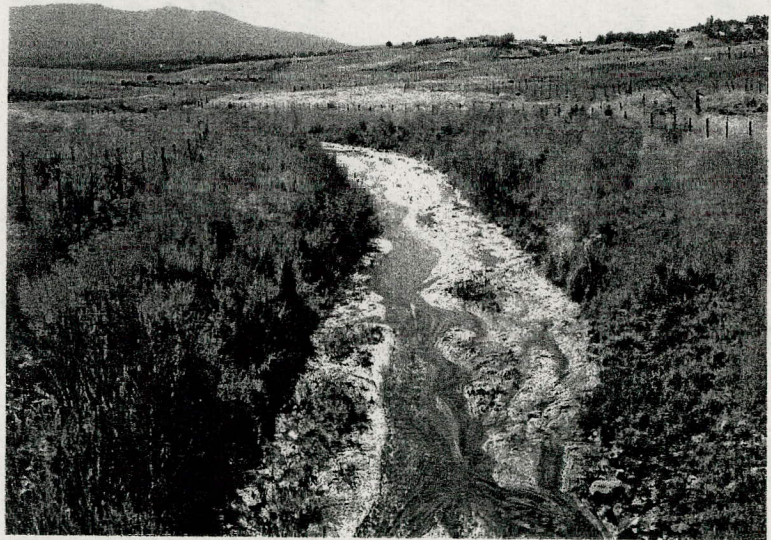
Photo 16 – Phase IV Montezuma Creek, eastern end, view west

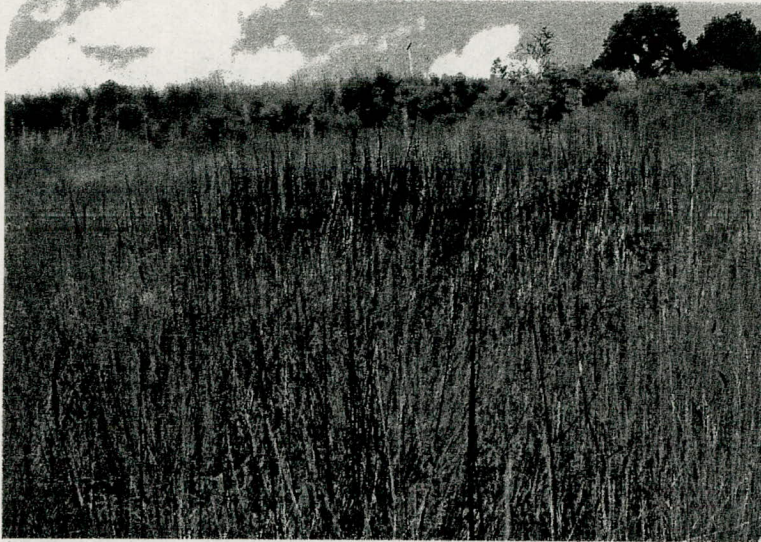
Photo 17 – Pumphouse 1 Seep, view uphill of original seep area

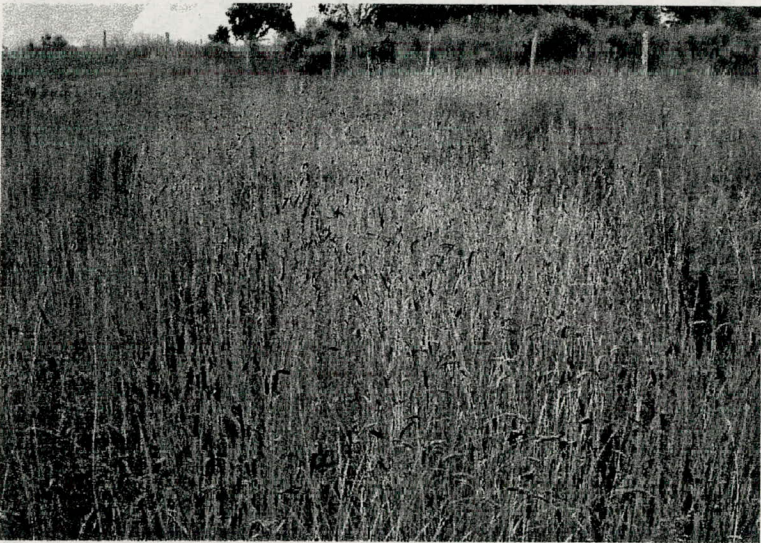
Photo 18 – Pumphouse 2 Seep, eastern portion of seep

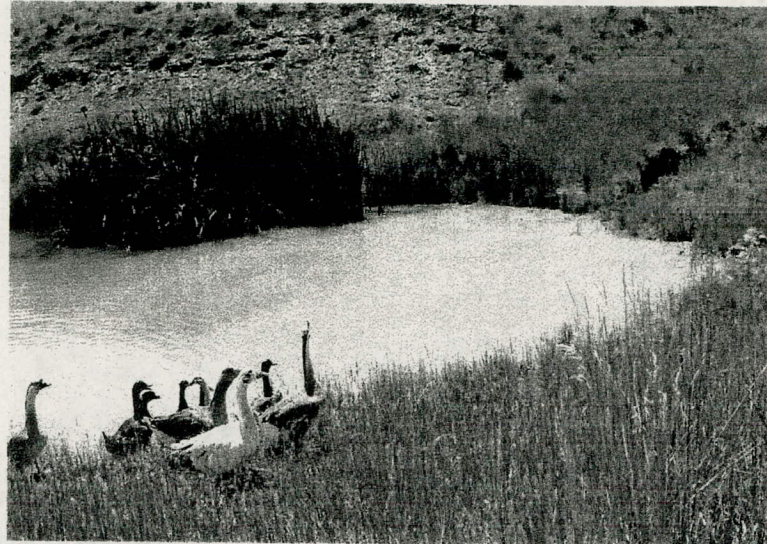
Photo 19 – Upper North Drainage, wetland and pond, view south

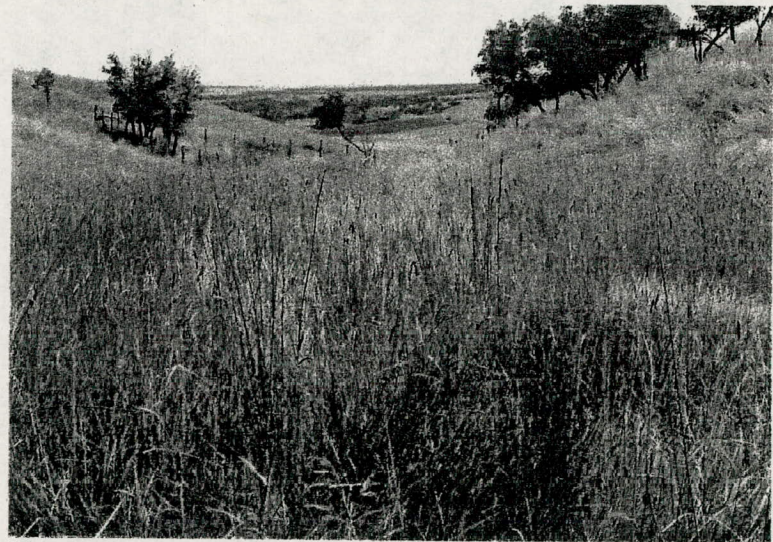
Photo 20 – Upper North Drainage, view downstream from middle

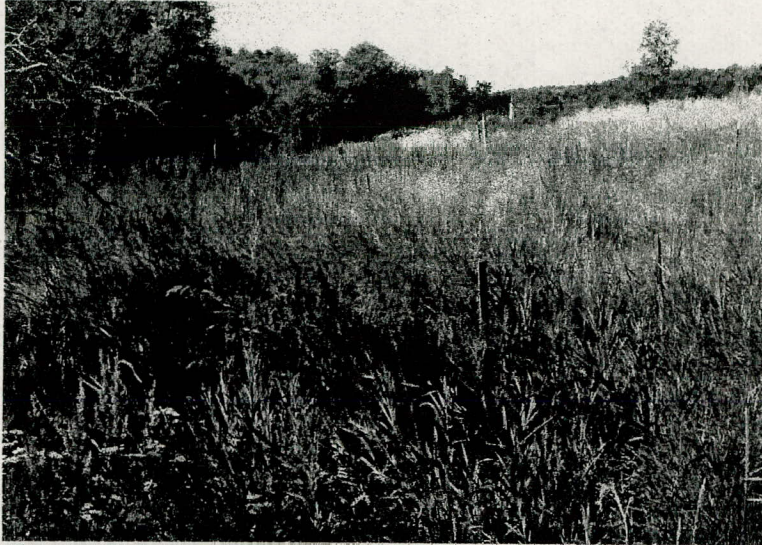
Photo 21 – Hill Side Seep, eastern portion, view west

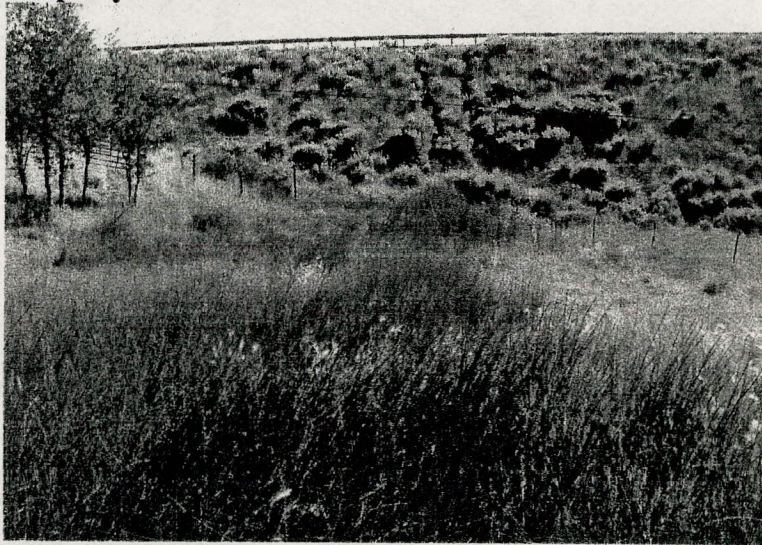
Photo 22 – Hill Side Seep, view east

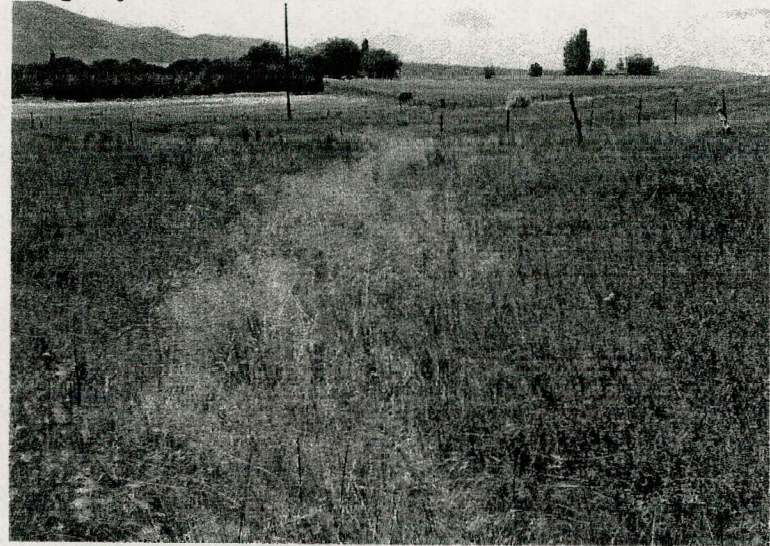
Photo 23 – Draw, view west-northwest, near western end of wetland

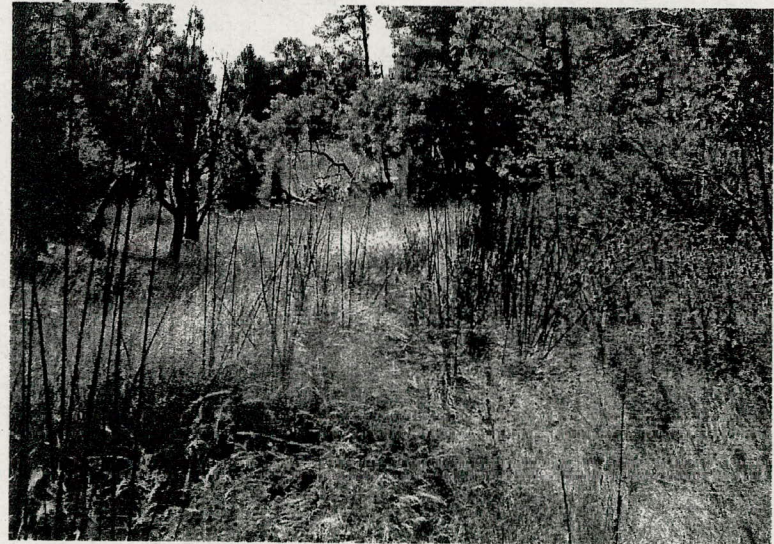
Photo 24 – Below Pond, view south

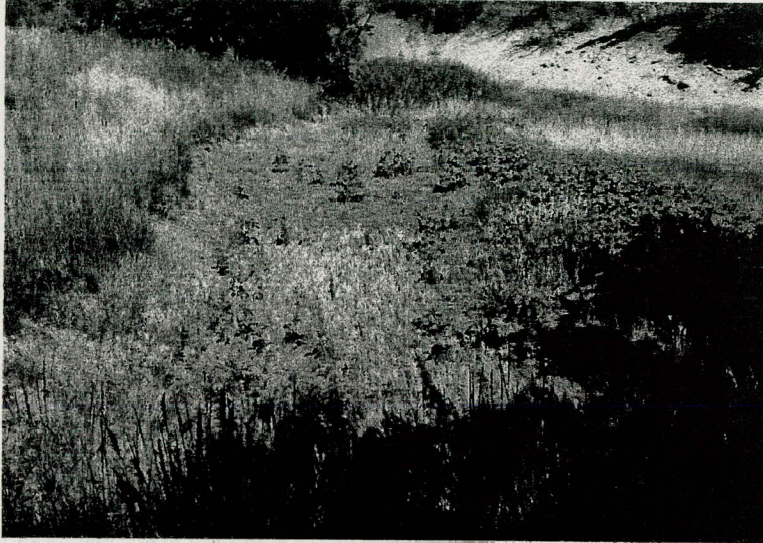
Photo 25 – Edge of Pond, view west-northwest

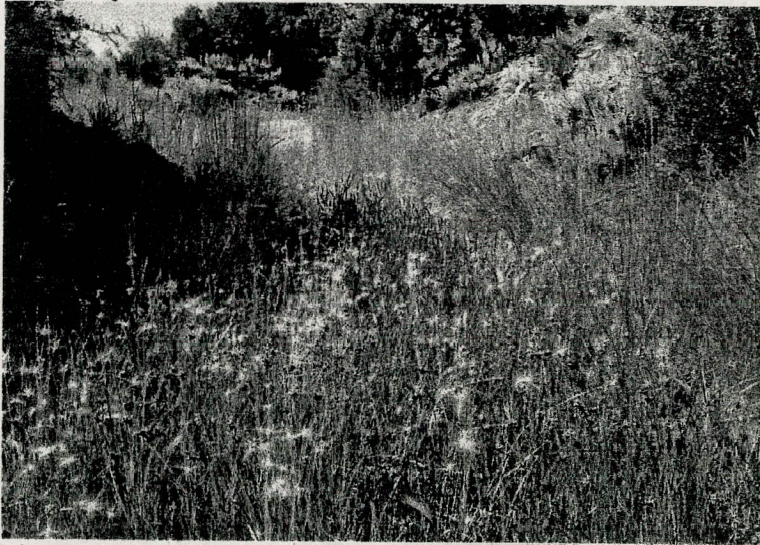
Photo 26 – Haul Road Wetland, view south

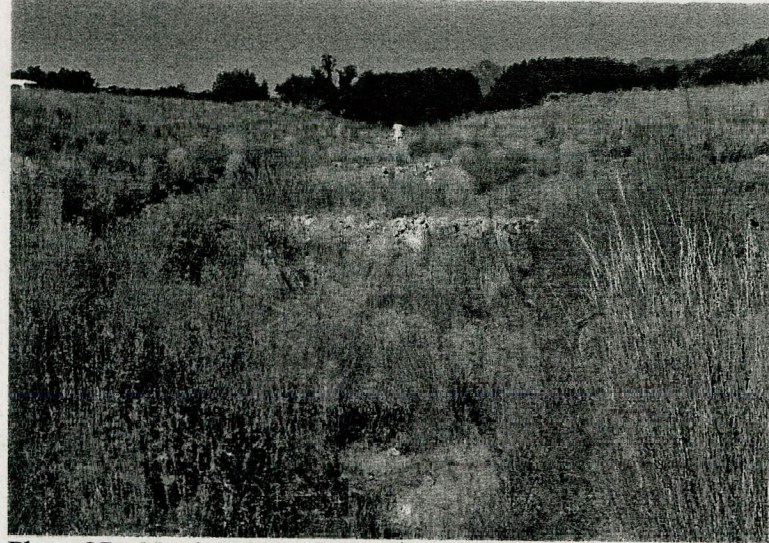
Photo 27 – North Draw, view east, downstream

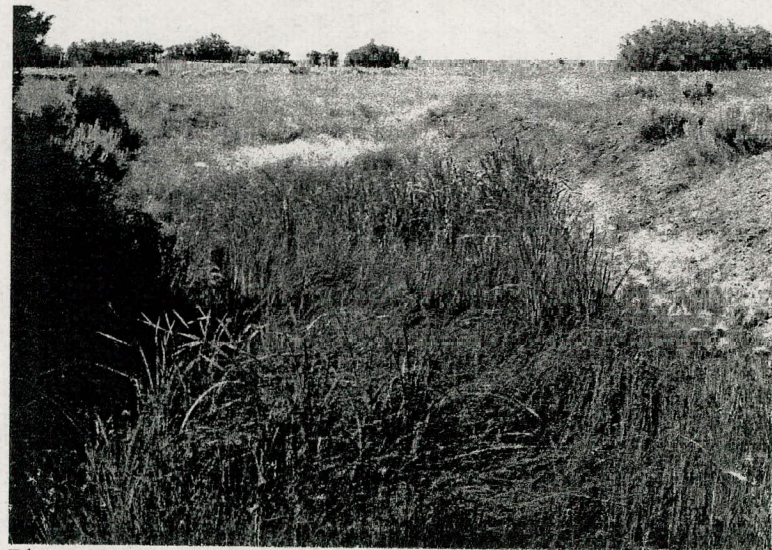
Photo 28 – South Depression/Pond, view south-southeast

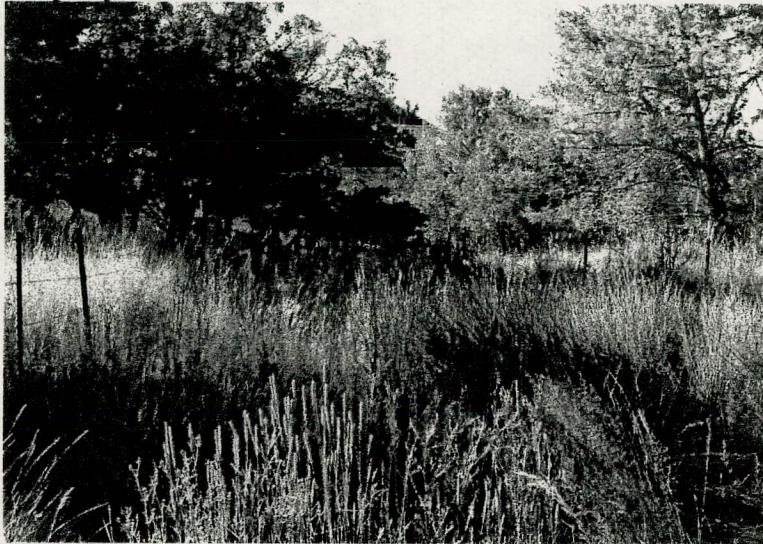
Photo 29 – Ground Water Drainage 2, view south

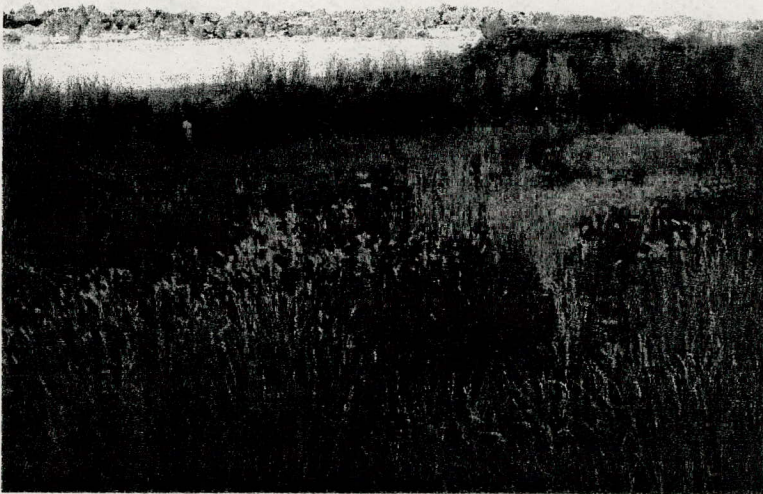
Photo 30 – Deposit K, view south

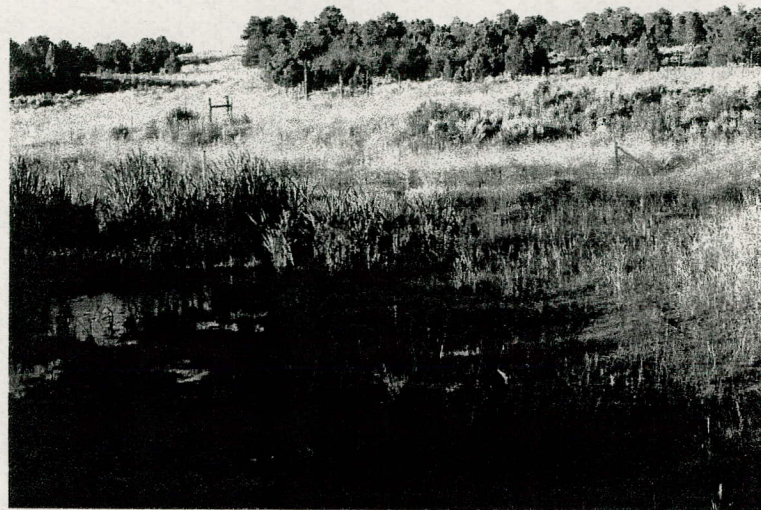
Photo 31 – Pipeline Wetland, pipeline crossing, view south

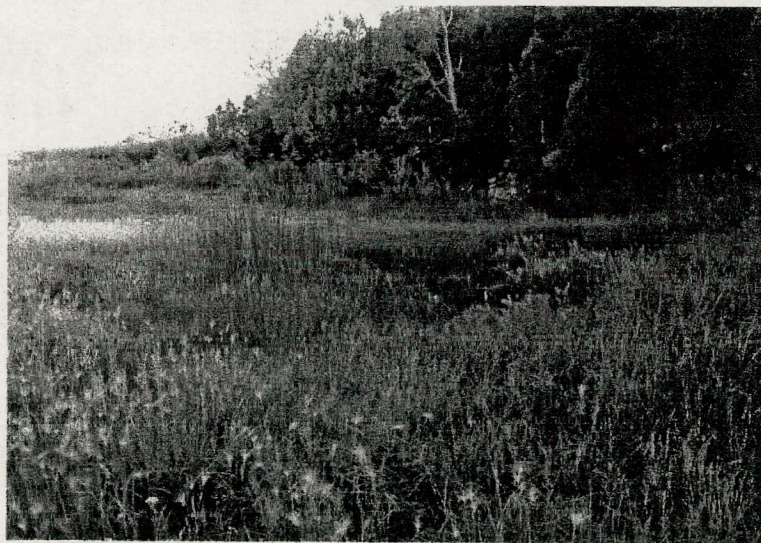
Photo 32 – Deposit CC, view northwest from irrigation stop gate

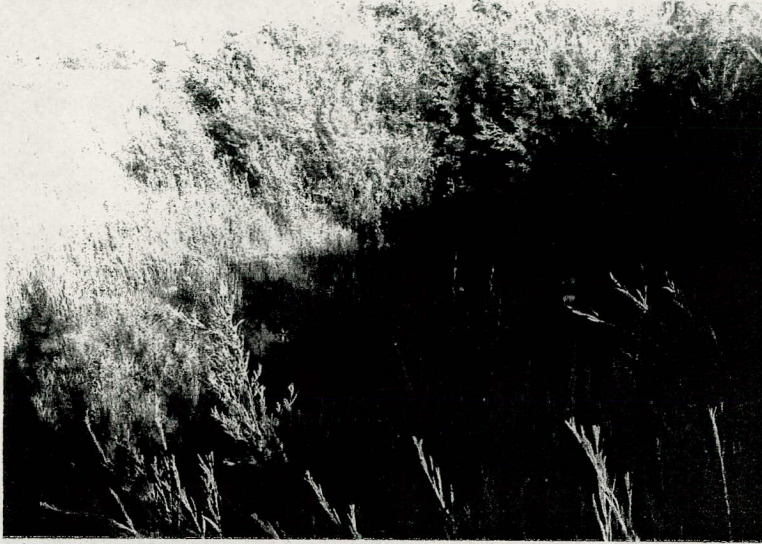
Photo 33 – Deposit DD, view west

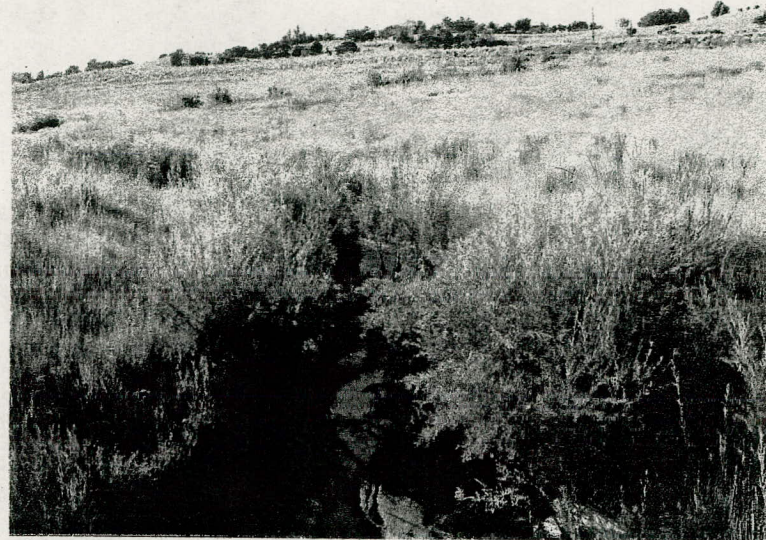
Photo 35 – Montezuma Creek, view upstream from eastern bridge

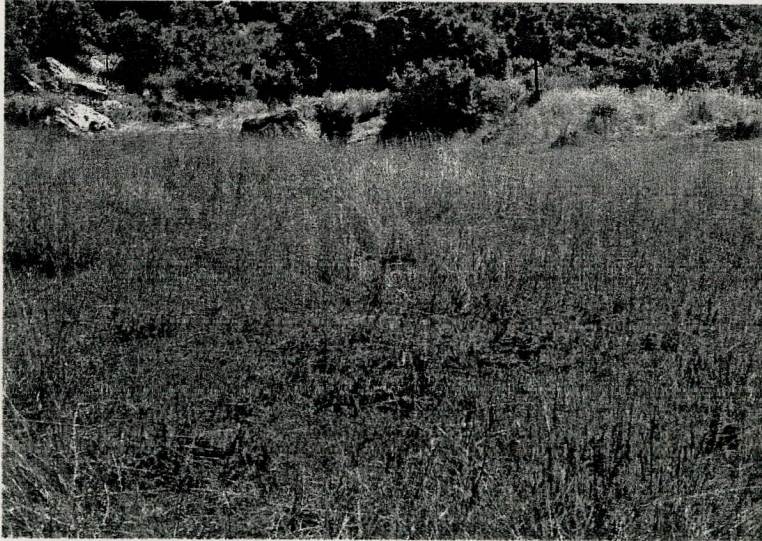
Photo 34 – Hot Spot D, view east

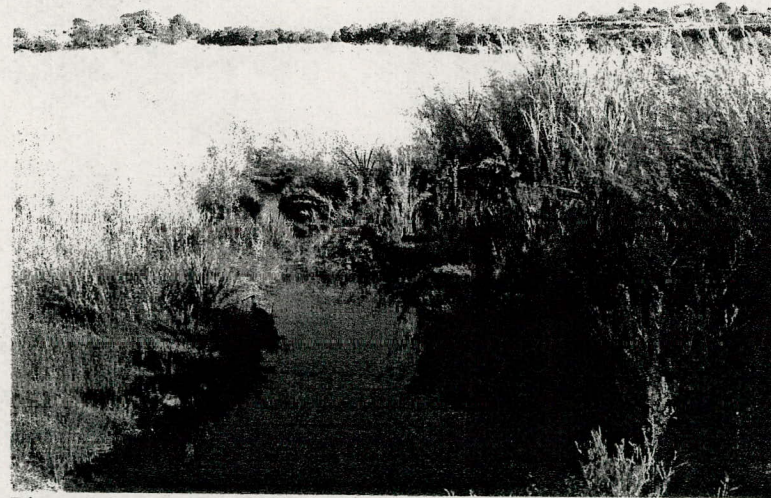
Photo 36 – Montezuma Creek, downstream from outlet of Backwater Wetland #1, view northeast

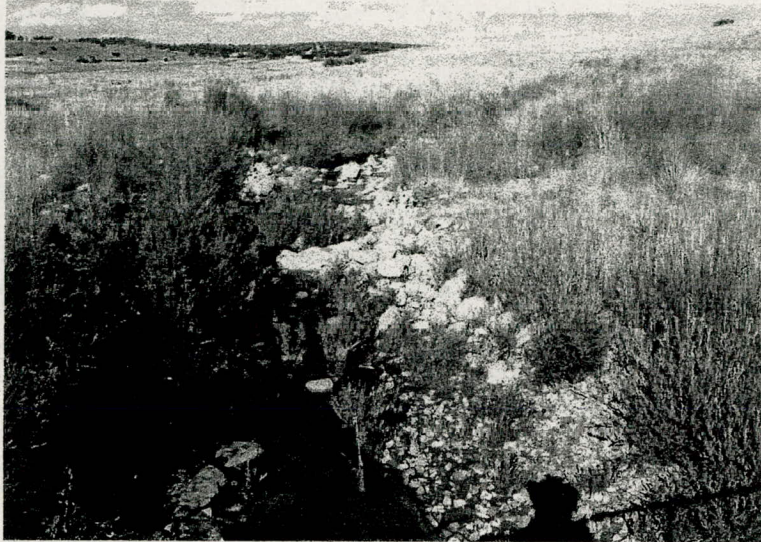
Photo 37 – Montezuma Creek, new wetland area, view east from footbridge

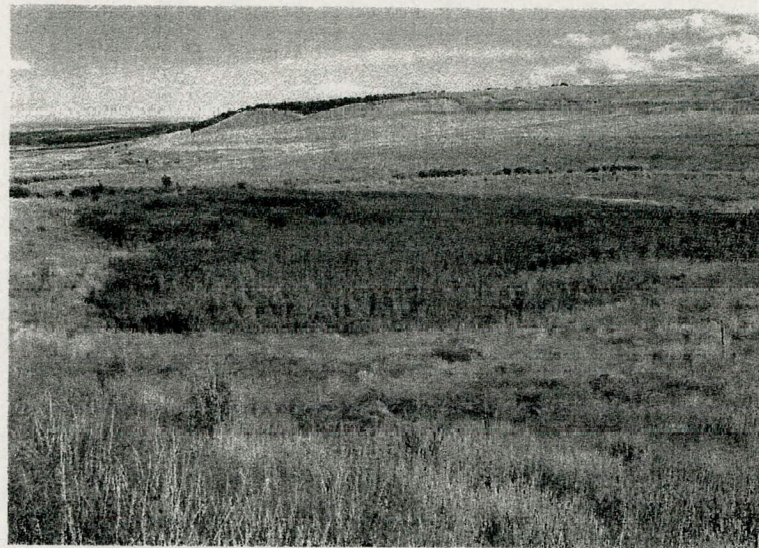
Photo 39 – Backwater Wetland #2, view southeast from access road

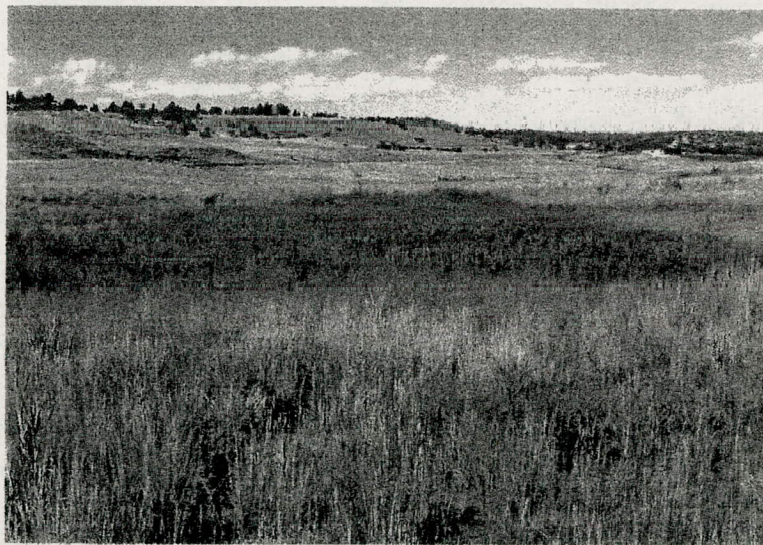
Photo 38 – Backwater Wetland #1, view east from the road

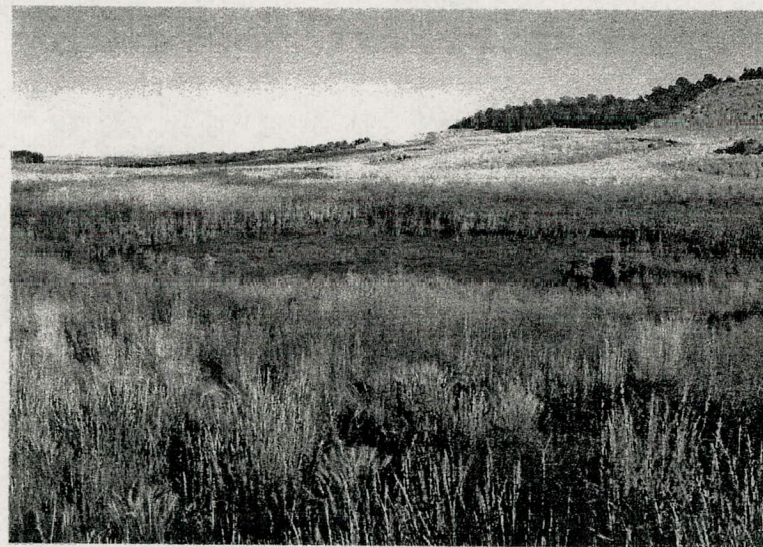
Photo 40 – Backwater Wetland #3, view east-southeast

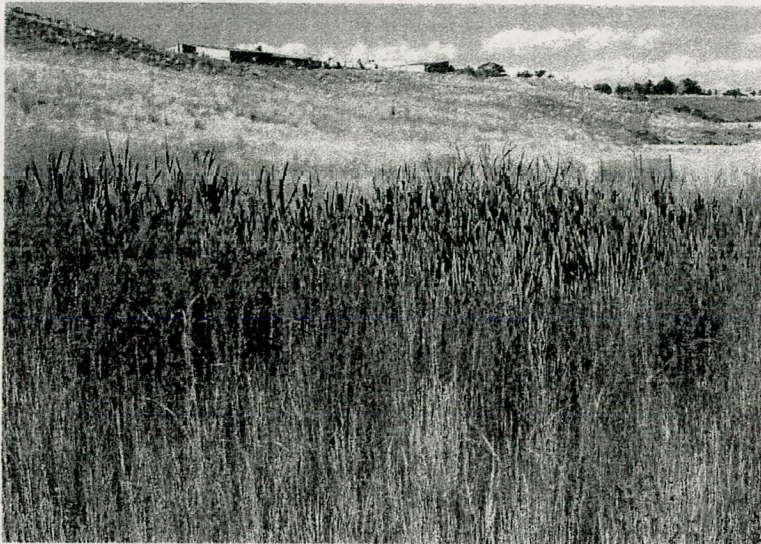
Photo 41 – Seep Pond, view east-northeast

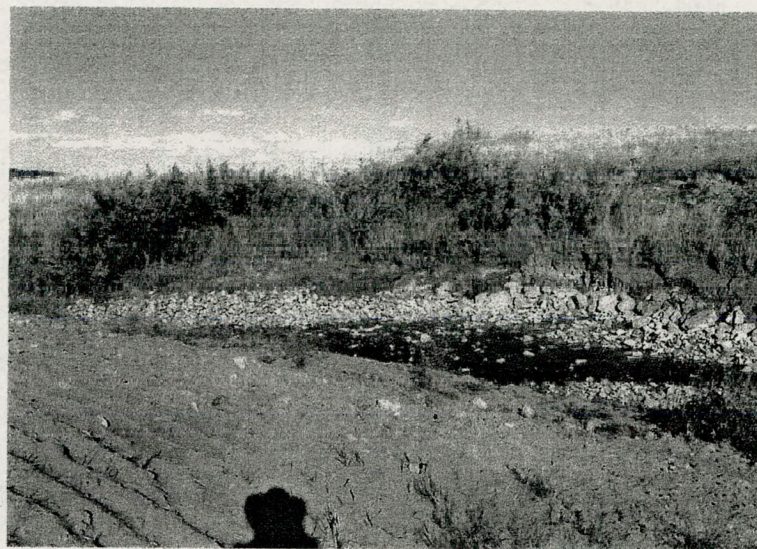
Photo 43 – T-01-28 Seep, view east

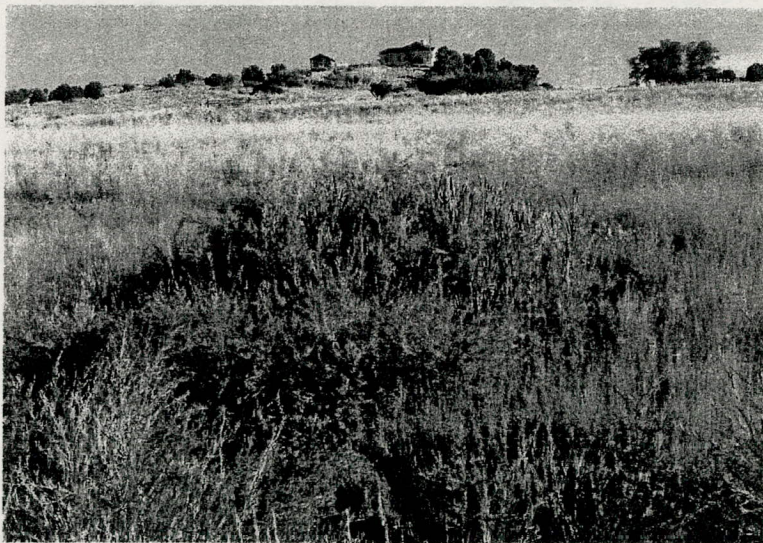
Photo 42 – T-01-27 Seep, view south

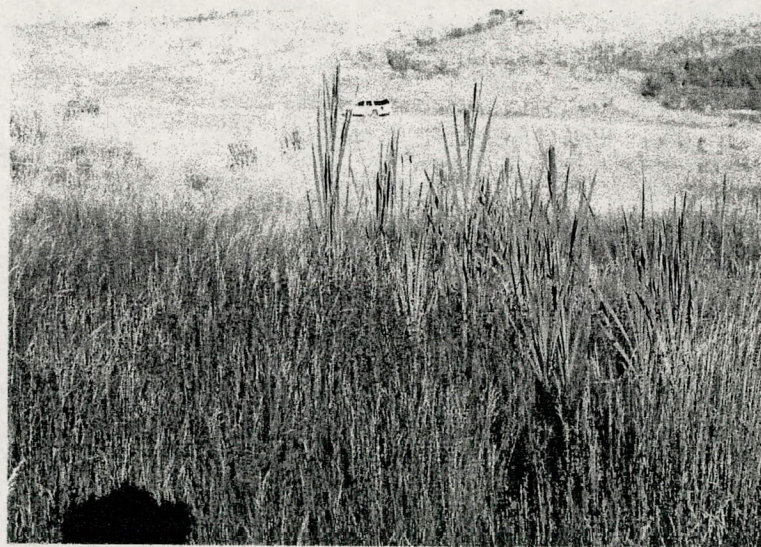
Photo 44 – Highway Seep, view southeast, downslope

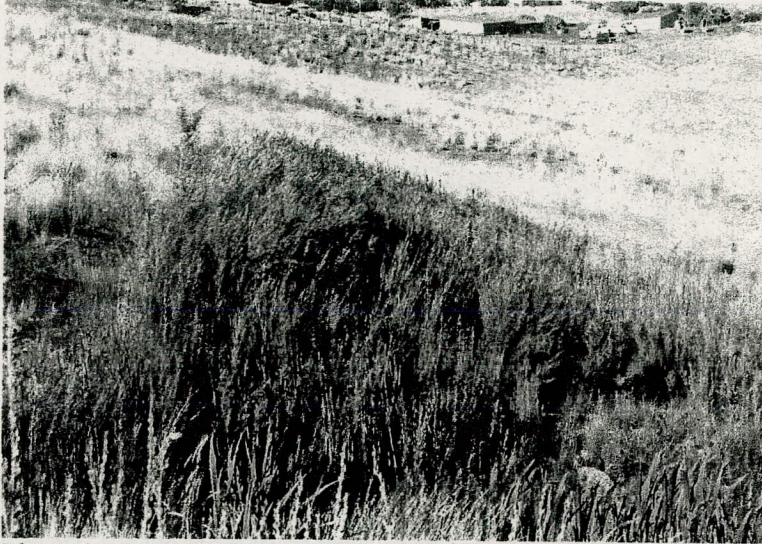
Photo 45 – Goodknight Spring, main drainage area, view north

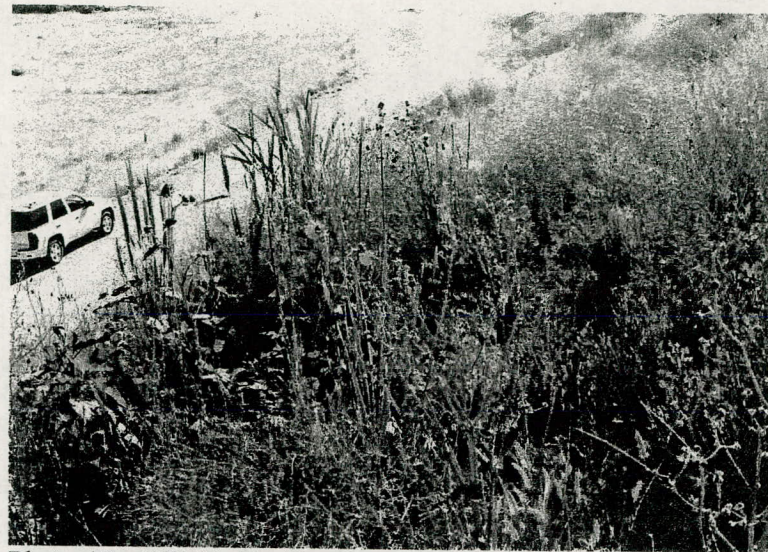
Photo 47 – Hillside Far East Seep, view southwest

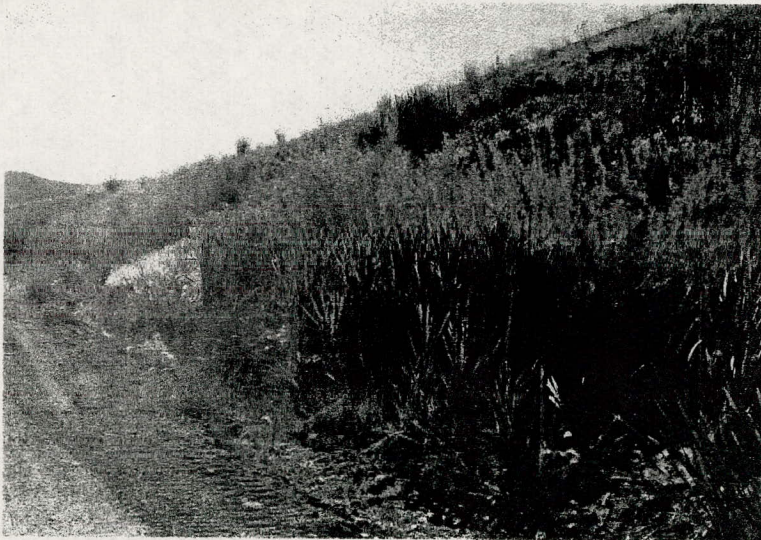
Photo 46 – Hillside East Seep, view west-northwest

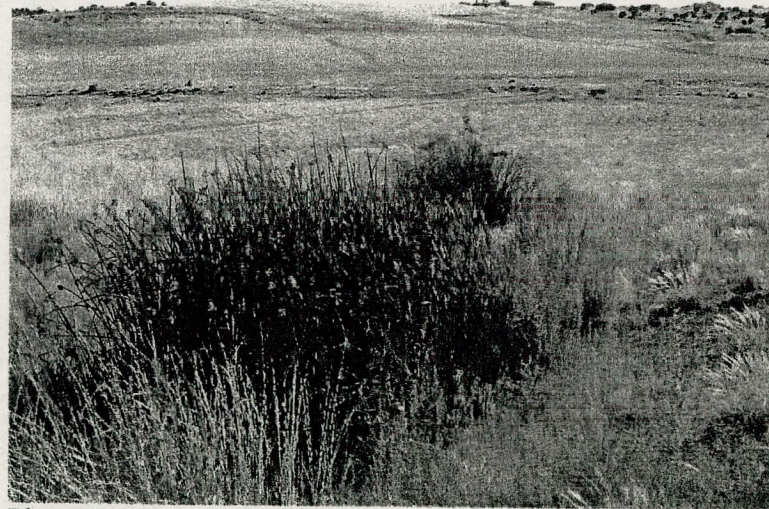
Photo 48 – Seep #3 Drainage Way, view southwest
